EQUIPMENT CONDITION INVENTORY	
BUILDING ASSESSMENT	
D.C. DEPARTMENT OF GENERAL SERVICES	
LINCOLN THEATRE 1215 U STREET, N.W. WASHINGTON, DC PO388329	
TYPE OF EQUIPMENT	: Main Switchboard
LOCATION	: Basement Electrical Room
IDENTIFICATION NO.	: MSB
MANUFACTURER	: General Electric
NO. OF CUBICLES	: 7 Sections
EQUIPMENT CONDITION CODE <small>RED: Poor condition. Severe deterioration. YELLOW: Marginal condition. Moderate deterioration. GREEN: Acceptable condition. Limited deterioration.</small>	
CODE	: Green
AGE (YRS)	: 20 years
TYPICAL USEFUL LIFE (YRS)	: 50 years
REMARKS : Ammeter not functioning. GE#72298872; Plant # T222 Inspected by Kolb Electric 4/5/04

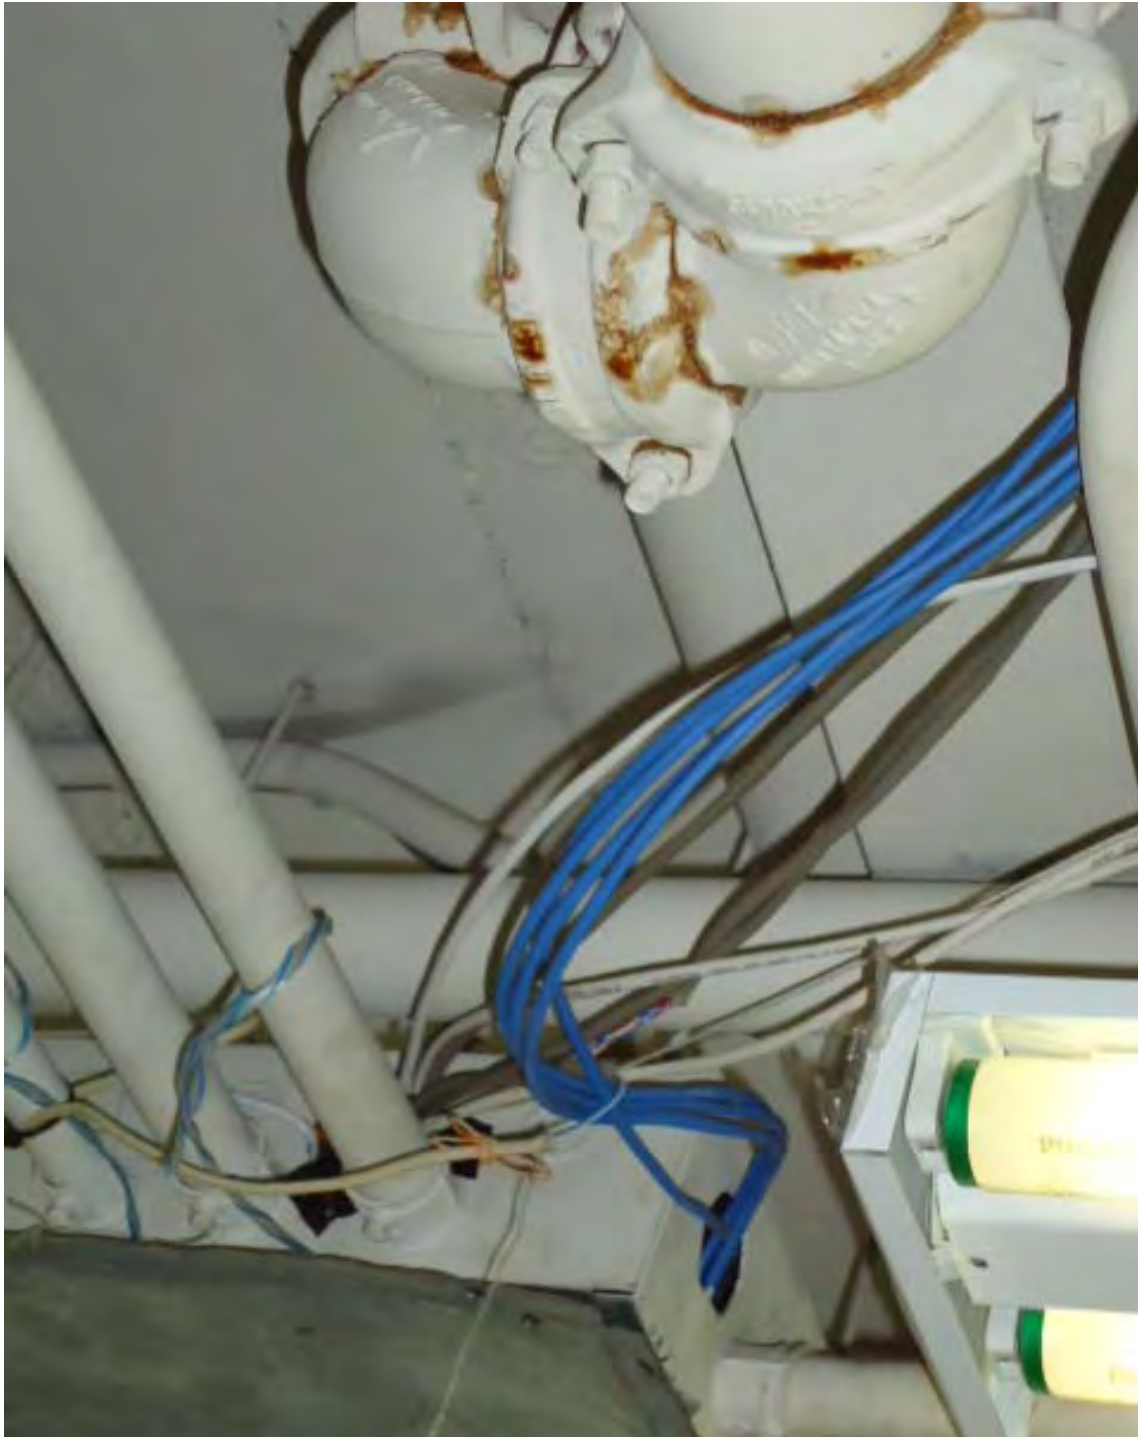
Improperly supported cables. Grommets not provided for protection.

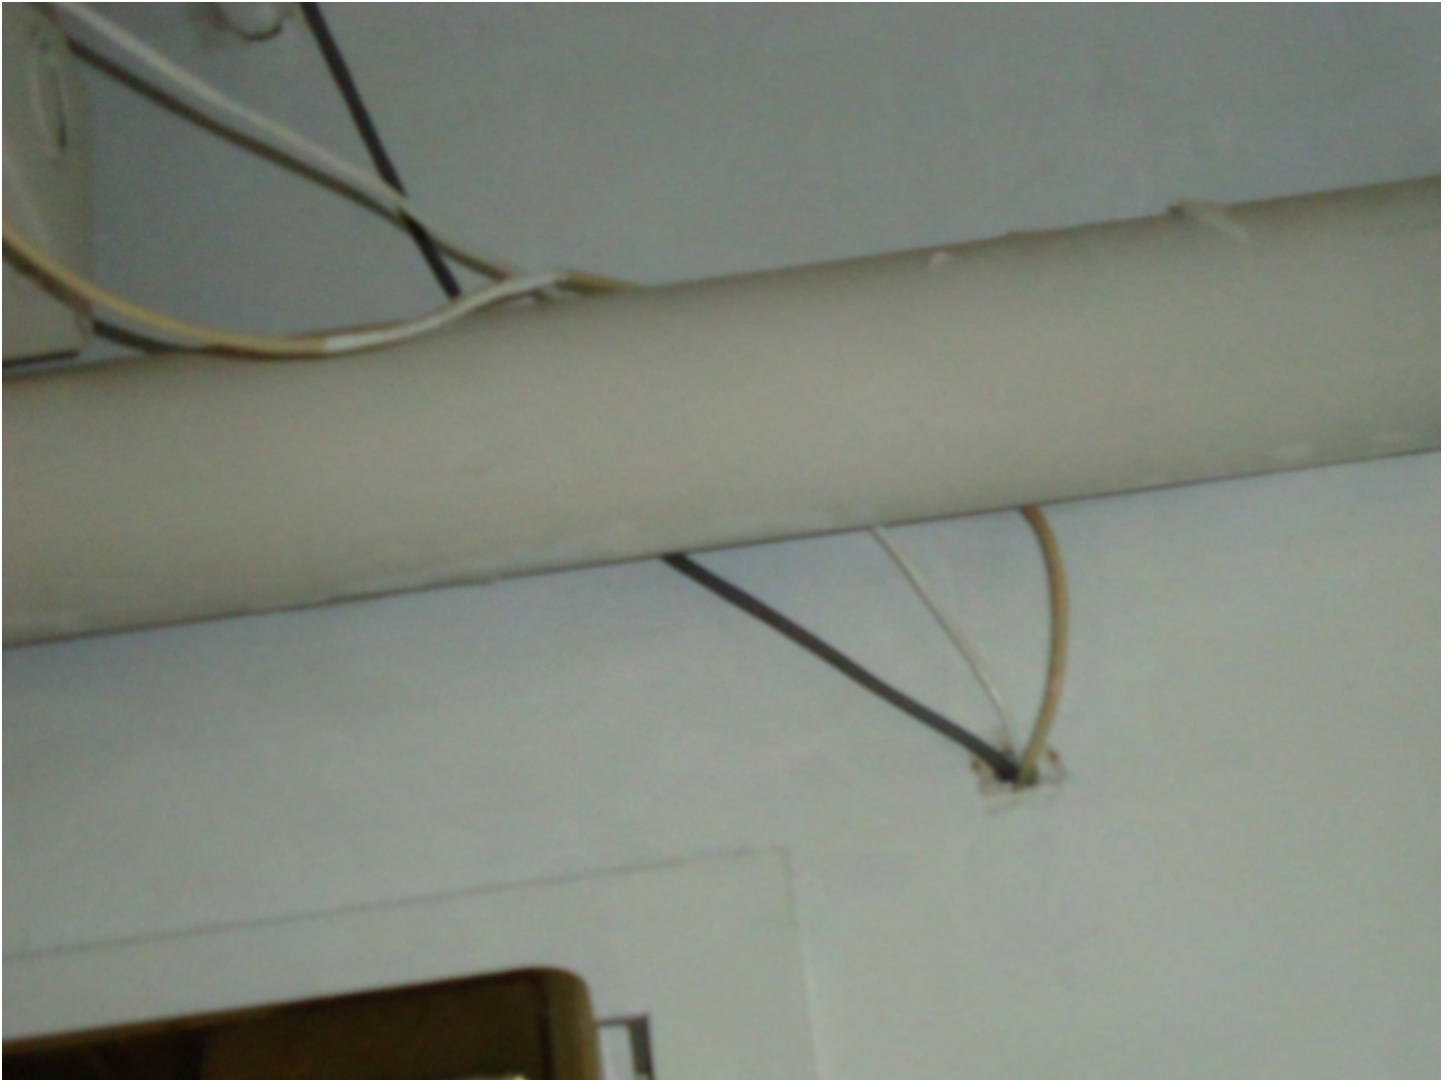
Improperly supported cables.

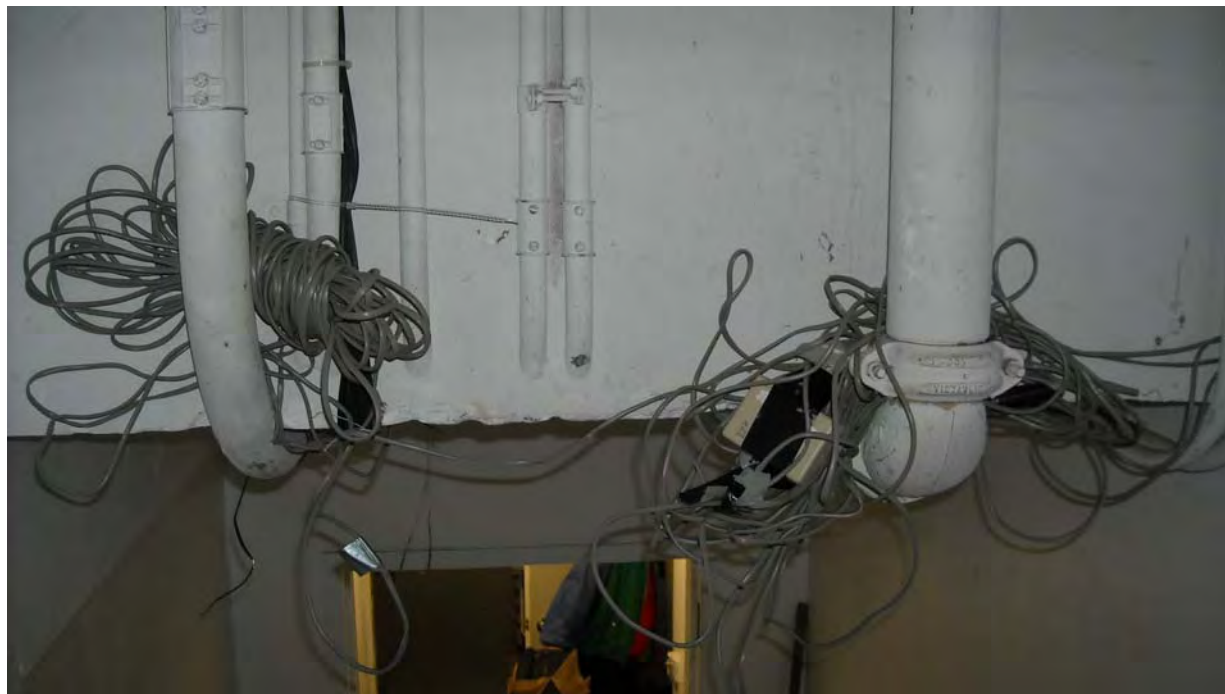
Abandoned cables or unused cables not properly supported.

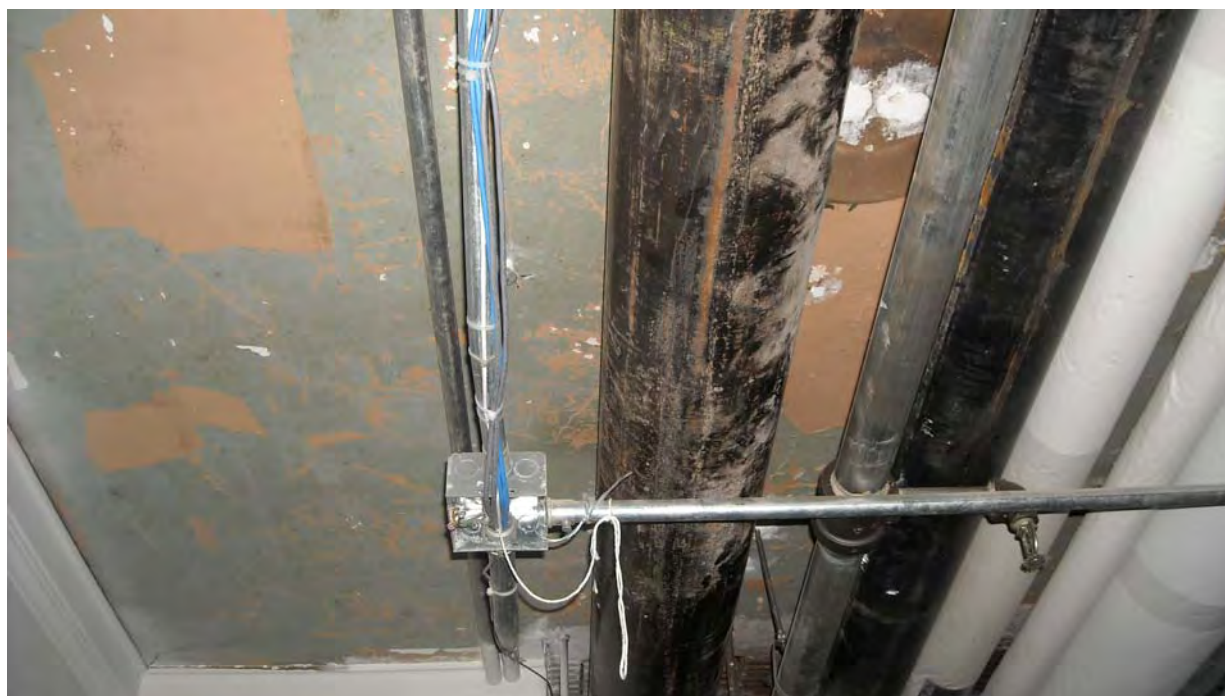
Improperly supported cables. Pull box cover is missing.

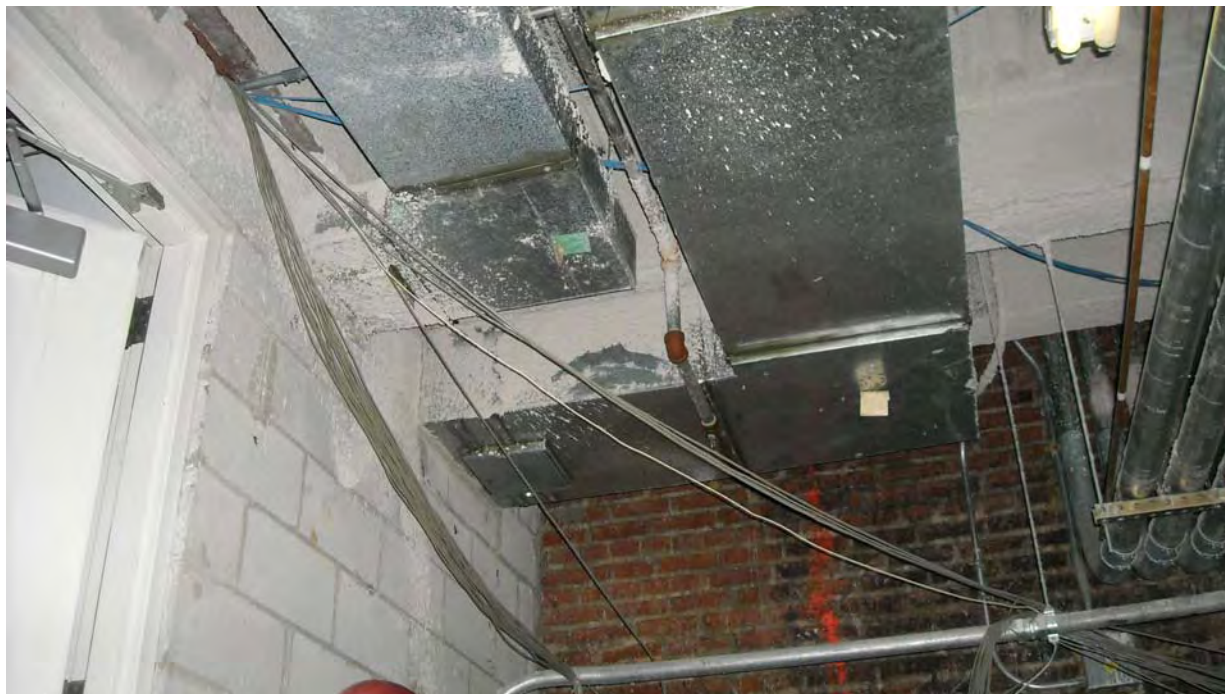
Improperly supported cables. Insufficient fire stop.

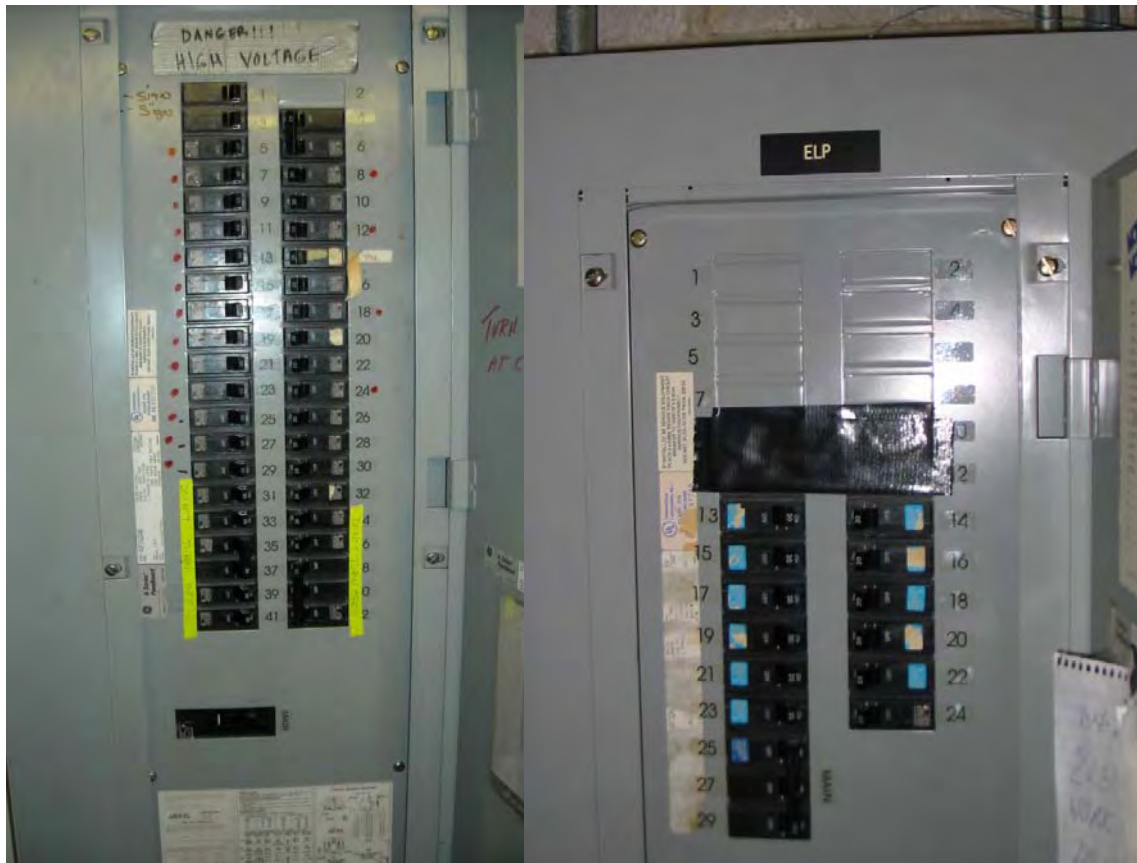
Typical panels. Provide updated labels, panel schedules. Remove tape and provide space covers.

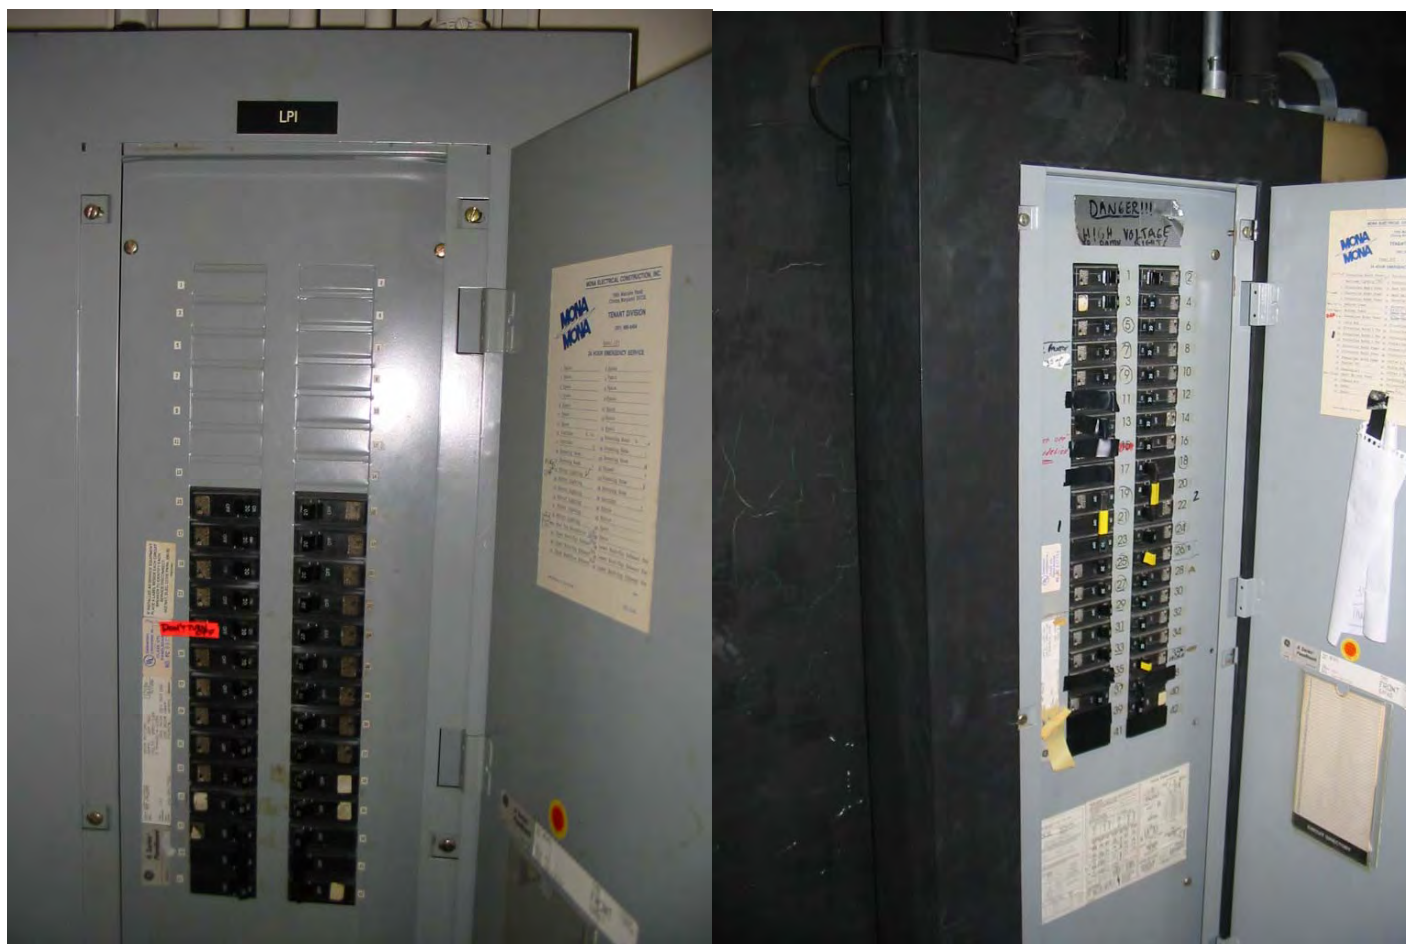
Typical Panels. Remove tape and provide handle lock-on devices.

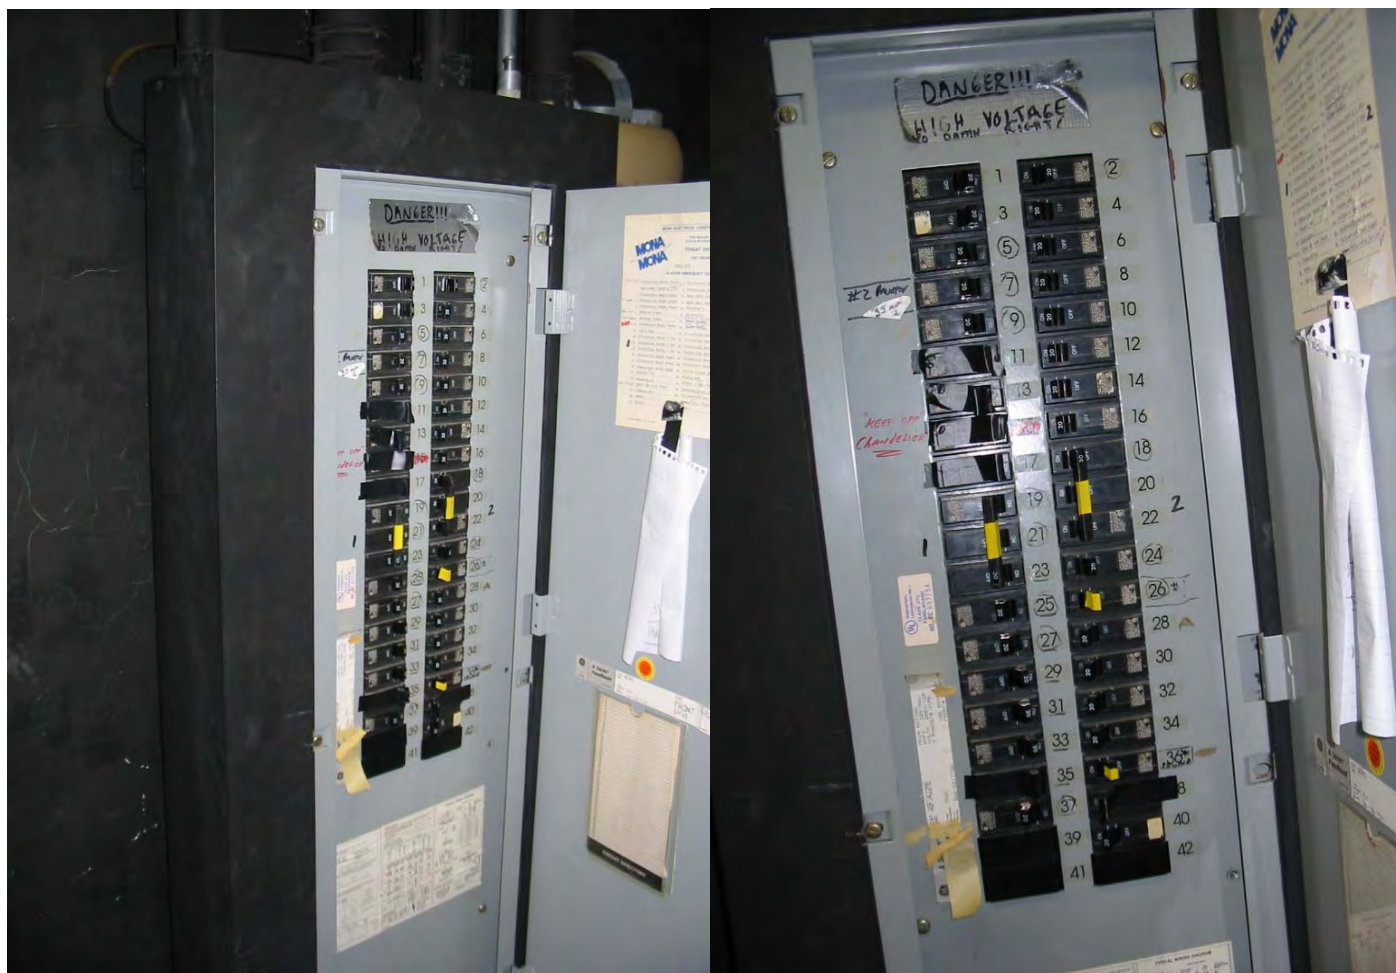
Panel PS2 in Projector Room. Lock on devices should be installed to replace tape.

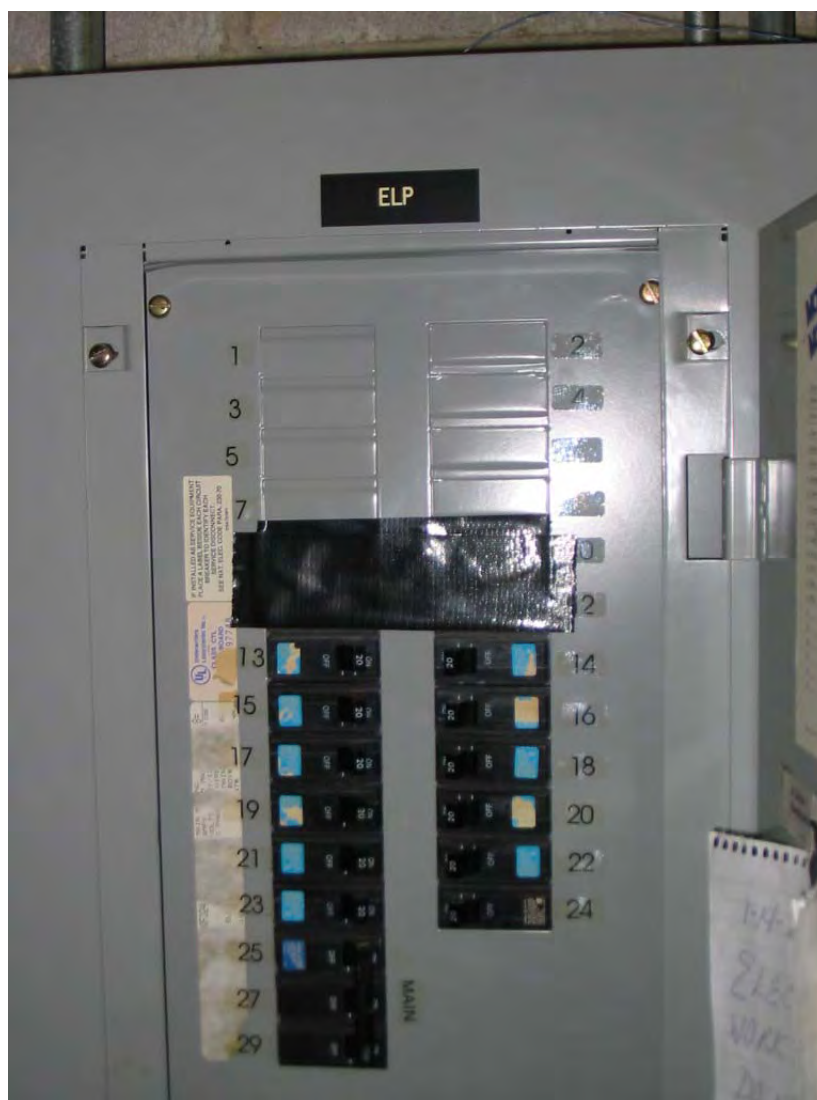
Three (3) panel blanks are not provided

Panel ELP in Main Electrical Room
Tape is not a code compliant space cover. Covers shall be provided.
